**Epiphany Lutheran Church  
5515 Broadway Street  
Pearland, Texas 77581**

**FACILITY ASSESMENT REPORT  
October 20, 2018**

**Studio Red Architects, Inc.  
1320 McGowen  
Houston, Texas 77004  
713-622-5333**

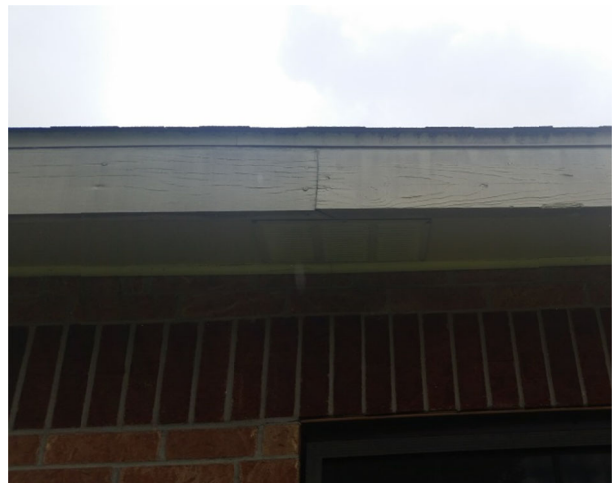
The existing fascia, soffit, frieze board, and scotia appear to be painted wood. It is not clear if the material is pressure treated to resist rot. Most of the existing material appears to be in good condition, although there are locations where the scotia and frieze are missing sealant where it adjoins the brick. It is recommended that the building be re-painted in the next 1 to 2 years. At that time, any deteriorated

*Figure 1: Water damage seen on existing fascia; weep joints missing at lintel.*

fascia or soffit boards should be replaced with pressure treated lumber or cementitious fiberboard such as Hardi or other product. All joints between the frieze/scotia and brick should be sealed with caulk.

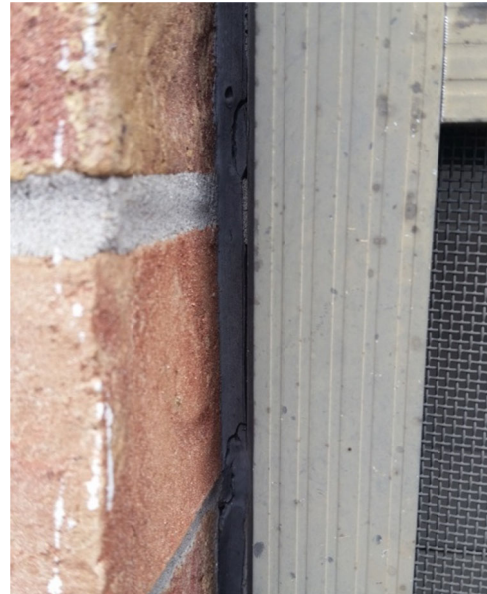
*Figure 2: Caulk splitting and separating from window.*

The existing windows are single-pane, double-hung aluminum unit windows and appear to be in good condition. It is recommended that the sealant between the windows and adjacent brick be repaired or replaced as several locations are showing signs of splitting or separating from the adjacent brick, see Figure 2: Caulk splitting and separating from window. Existing windows are not compliant with the currently adopted energy code. Depending on future renovations or expansions, these windows should be replaced with new units meeting code requirements. It is anticipated that new units should be double-paned, insulated units with low-e coated glazing. Additionally, it was observed that all lintels over openings, including windows, did not have full head weep joints at the brick, see Figure 1: Water damage seen on existing fascia; weep joints missing at lintel.. It is recommended that weeps be added to relieve water that may be trapped in the wall cavity. Inappropriate drainage of the cavity can lead to deterioration of the lintel or infiltration into the building.

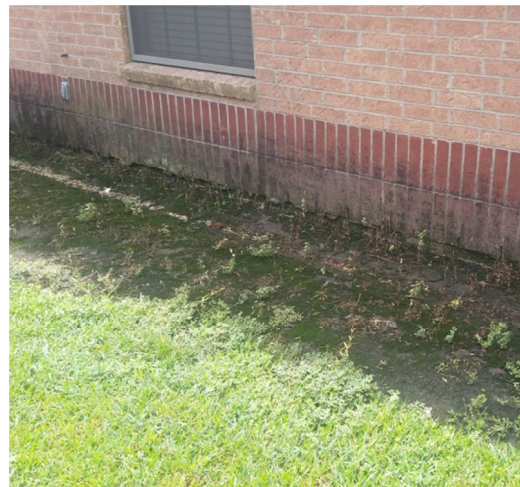
The existing building is mostly surrounded by unpaved areas which mostly contain grass but some areas include landscaped beds. The pitched roof sheds water to these areas as well along eaves; the only area of the existing roof that has gutters is located along the front (southwest) façade. The grass areas are mostly flat and there are no visible signs of positive drainage, see Figure 3: Poor drainage near foundation. Despite this, it is understood from church staff that there have not been issues with drainage around the building, especially events of water infiltration. During Hurricane Harvey in 2017, there were no instances of water entering the building despite heavy, prolonged rainfall. Regardless, it is recommended that all eaves of the building have gutters installed that deliver roof drainage through downspouts to underground drains. Eaves that already have gutters are tied to underground drains that

*Figure 3: Poor drainage near foundation.*

carry water away from the building to pop-up relief drains. All gutters should be tied to underground drains that are connected to storm drains either existing under the parking lot or new storm rains which will flow to the existing detention pond. This will more effectively convey water away from the building. Poor drainage can lead to water seeping under the foundation and ultimately to differential settlement of heaving of the slab.

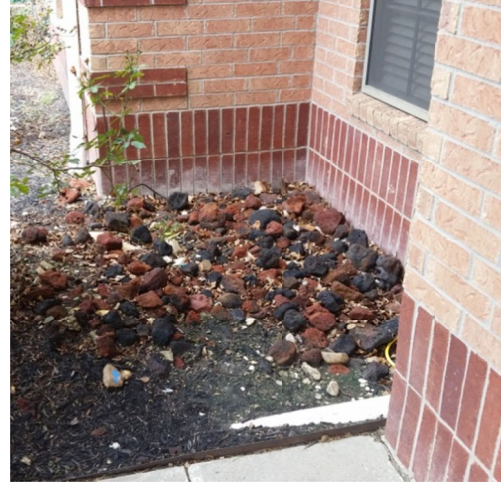
In the landscaped beds along the southwest face of the building, it was observed that mulch was piled against the brick building and in front of the existing weeps, see Figure 4. This should be removed and all finish grade including mulch be kept below brick weeps. Blocked weeps can lead to inappropriate drainage of the cavity can cause water to enter into the building as well as provide a conduit for insects into the building.

*Figure 4: mulch and landscape rocks applied directly against weep openings.*

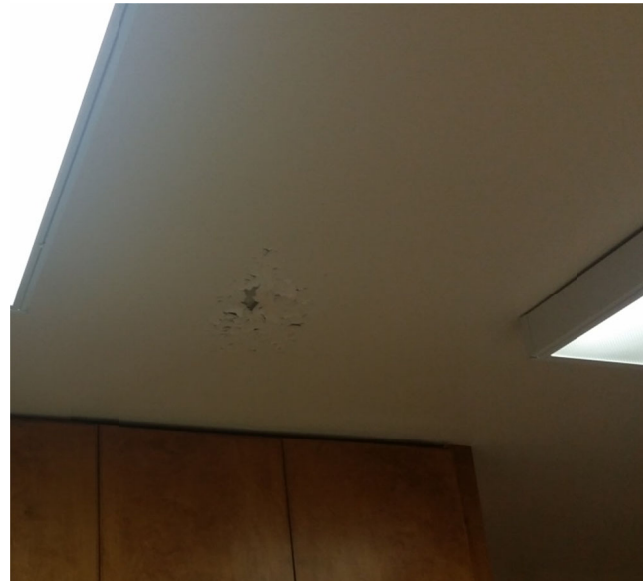
Several instances of peeling paint were noticed during the inspection; specifically on the rear wall of the worship space, on several walls in the Narthex, and on the ceiling of the kitchen space, see Figure 5. Church staff indicated that this was a known issue that the church has been experiencing for several years and that the problem has persisted throughout the building. There are several likely causes of the issue including humidity issues, improper application, improper material use, and defective material. But a direct cause cannot be readily discerned without further investigation, the likes of which are beyond the scope of this report. At the time of this report, the church was soliciting a third party opinion and potentially testing of the affected areas and substrate to determine the cause. Upon findings from the testing, recommendations for how to remedy the issue can be made.

*Figure 5: Peeling paint on Kitchen ceiling*

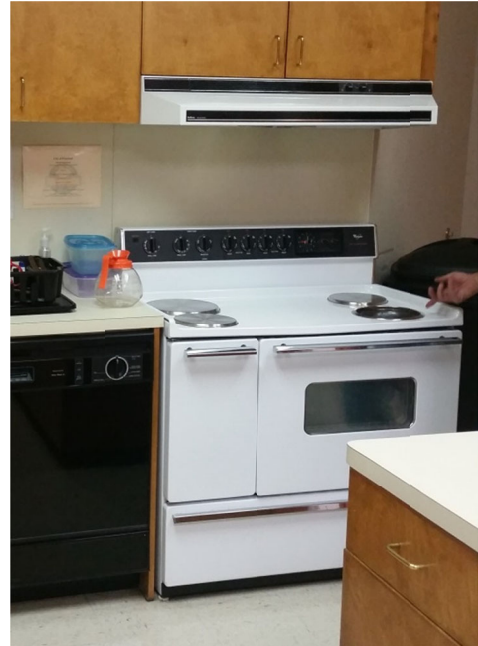
another element that would be required if the space were used cooking meals. A residential style exhaust fan is located over the range; current codes would require this to be changed for a commercial grade grease hood with appropriate infrastructure. It should be noted that the range did not have any active cooking elements. The elements were removed in order to comply with the MDO program regulations. If the intent for the kitchen is to continue to be used in the manner it is used today, it would be recommended to fully remove the appliances and convert the space to a breakroom or staging area rather than a kitchen, see Figure 6.

*Figure 6: range with heating elements removed.*

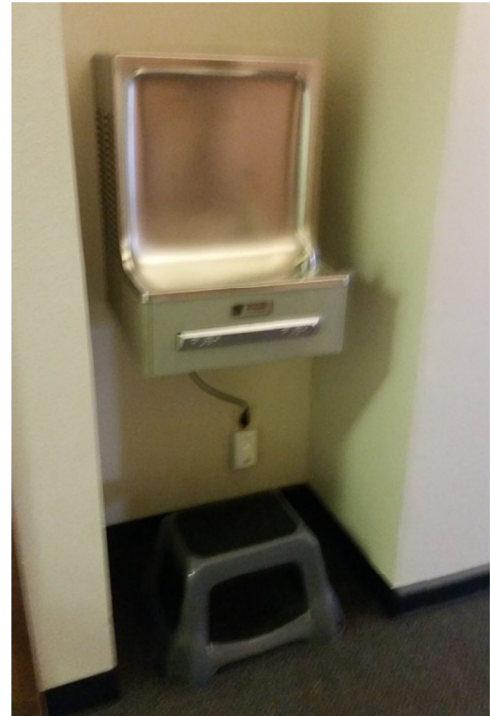
*Figure 7: drinking fountain is not accessible.*

requirements. The existing drinking fountain will also need to be replaced with a dual-height unit that provides the appropriate knee clearance as well as service height of the water spout. The alcove will need to be widened to provide for the dual-height unit, see Figure 7.

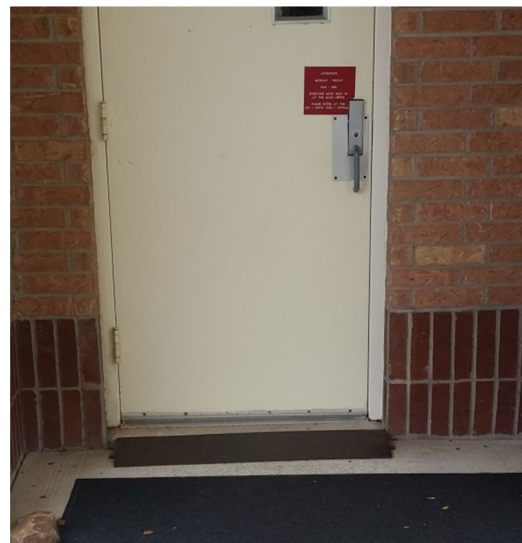
*Figure 8: un-accessible threshold at west entry door.*

All areas of the building should be provided with an accessible route meeting requirements that links the space to areas which serve the primary function, egress points, building entrances, the parking lot, and point of arrival. The route should have a minimum width of 36-inches (can be restricted to 32-inches at doorways), have a travel surface meeting certain slope requirements and not having a change in vertical height more than 1/4-inch, among other requirements. The majority of the existing building appears to meet this requirement, however further investigation is required as part of a project. Specifically, the door at the West Entry has an inappropriate threshold that does not meet compliance, see Figure 8. The paving outside the door will need to be removed and replaced such that the change in height at the threshold will meet this requirement.

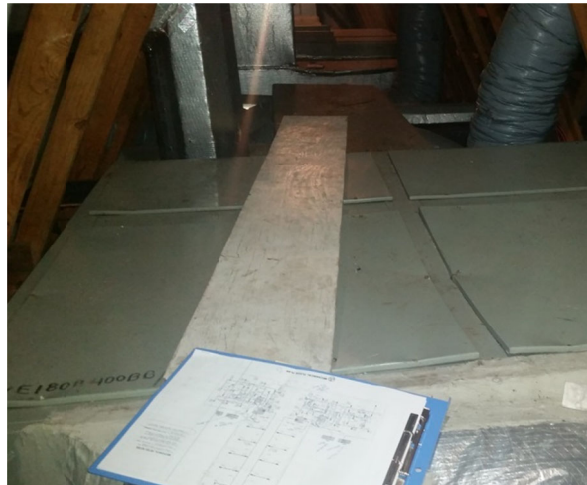
Another challenge with the existing AHU's is where they are located and configured, see Figure 9. Being placed in the attic, access is difficult and not ideal. Further, the limited access to and around the units does not meet code which stipulates that a minimum access width be maintained around equipment. With future renovation and expansion projects, access issues will likely be required to be addressed. Given their location and limited availability to improve access, it is recommended that the church consider replacing all AHU's and ACCU's with single package units which can be located on the outside of the building. This will require reconfiguration of ductwork, but will resolve the access and longevity issues addressed in this report.

*Figure 9: a board is used to walk across top of AHU in attic.*

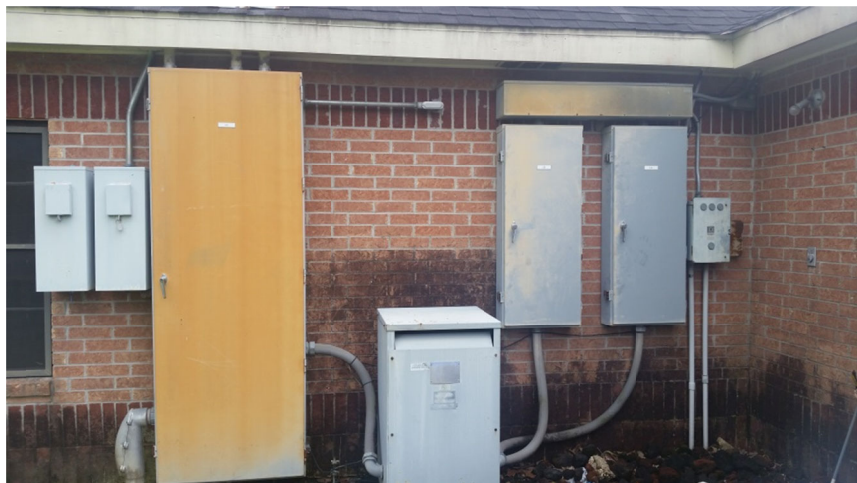
All of the building's electrical service panels, including Main Distribution Panel (MDP), transformer, and service panels are located on the outside of the building on the northwest wall of the sanctuary space, see Figure 10. This is not ideal for several reasons. The most immediate concerns is due to the potential for tampering, vandalism, and theft. A secondary concern is due to the acceleration of deterioration due to being exposed to the elements. Lastly, their location prevents the expansion of the worship center as the panels are situated along the side wall of the worship room. The current location of the panels on the outside of the building is allowable per code and may be costly to relocate, but if future projects allow for the panels to be relocated, it would be recommended that they be relocated to the interior of the building in a secured environment.

Figure 10: MDP, transformer, and service panels.
